## Ship hull corrosion caused by default and lack of maintenance on the impressed current cathodic protection

Fernando B. Mainier<sup>1</sup>, Vitor Perassolli<sup>2</sup>

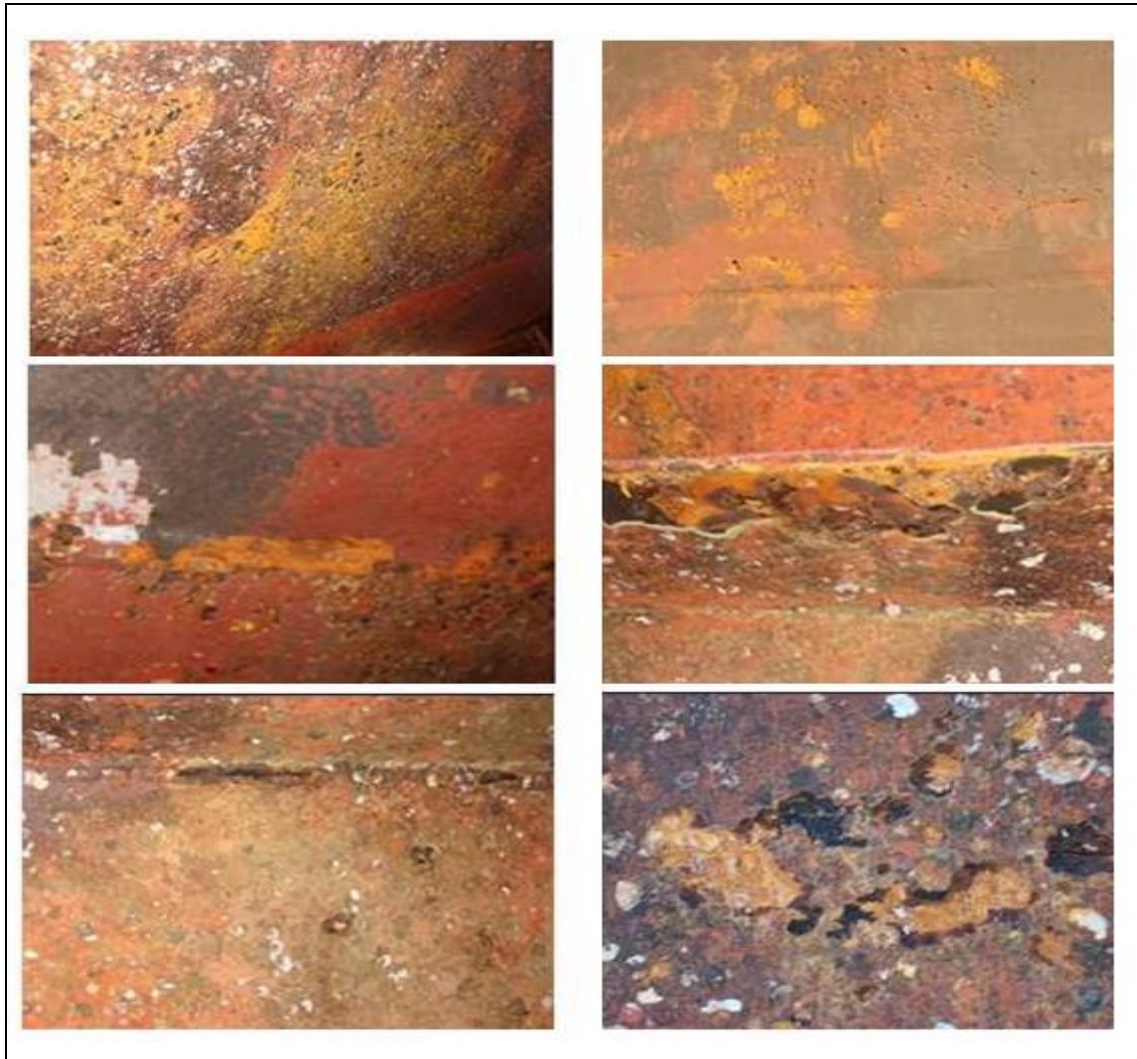
The photographic sequence (Figure 5) of the surface of the ship's hull, show an intense corrosion caused by seawater. Corrosion products shows various colorations, localised corrosion in the form of pitting, cavities (shallow, wide, or elliptical) and “holes”, barnacle depositions, residue of the antifouling paint (the inhibition of living organism growth on the surface), loose flakes of plates, and crevices. The pitting (narrow and deep) is more dangerous than uniform corrosion damage because it is more difficult to detect, predict, and design against. Considerable parts of the pitting are covered by corrosion products and shellfish adherents.

Some deep pitting resulted in perforation of the carbon steel plates. The products of carbon steel plate corrosion are primarily  $\text{Fe}_2\text{O}_3$ ,  $\text{FeO.OH}$ ,  $\text{Fe}_3\text{O}_4$ , and  $\text{FeO}$ . The white deposits result from the adhesion of shellfish, barnacles, and other sea animals present in seawater. Also on the surface of the hull were remains or vestiges of antifouling red paint.

Figure 5 – Photographic sequence of the surface of the ship's hull

The inspection of the ship revealed that 80% of the hull was compromised by corrosion on several levels, from the surface corrosion until the perforation of the carbon steel plate. Repair of ship's hull consisted of the pressurised water blasting, welding, and repair of the damaged carbon steel plates. Considering the existing past problems with the impressed current cathodic protection system that failed and compromised the hull has been chosen by galvanic zinc anodes system. Blasting with pressurised water and installation of zinc anodes are presented in Figures 7 and 8. The total cost to repair the ship was valued at \$ 85,000.

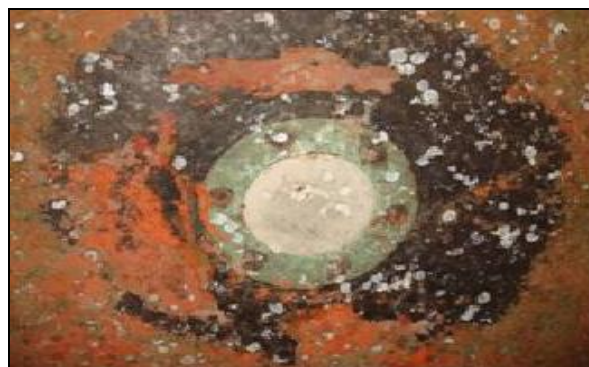
The inspection carried out in the ship's hull showed deterioration of the insulated support (Figure 6) where they installed the inert anodes of the impressed current cathodic protection system. Without the inert anodes, the system could not inject the necessary current hull protection.

Figure 6 – Insulated support of inert anodes

- It was not possible to evaluate the system because the impressed current cathodic protection system of the ship inspected did not work properly. It was not clear if the defect that occurred was due to direct current electric generator failure or because the inert anodes wore prematurely, as shown in Figure 6.
- Excessive wear of the inert anode in the impressed current cathodic protection system can be caused by injecting high electric current (non-controlled system) or inert anodes were made from of the standard quality.
- Hulls were not found vestiges of fixing of reference electrodes to continuously determine the hull in relation to potential corrosion-protection. This fact may suggest a lack of control of the anti-corrosion protection of the hull.
