Corrosion in surgical instruments

Abstract: - The surgical instruments that are on the market for use in medical and dental treatments, most of which are designed for specific actions in specific types of surgery, are usually manufactured from stainless steels, including AISI-420 and AISI-304, as well as titanium alloys. They are manufactured by many different companies, which means that the materials used to make them have a variety of sources, types of alloys, material quality, mechanical fabrication processes and costs. Surgical instruments are subject to contamination, or bacterial adherence to the instruments, from various sources, which can have an enormous impact on human health. Hospitals and clinics are well-suited environments for this to happen, since they concentrate both particularly susceptible hosts and highly resistant micro-organisms. Therefore, cleaning and sterilization of all surgical instruments after each use is essential. Typically, steam autoclaves and solutions of chlorine-based oxidants or similar chemicals are used. These methods of cleaning can cause premature deterioration of the instruments, reducing their lifespan. Unannounced inspections of hospital

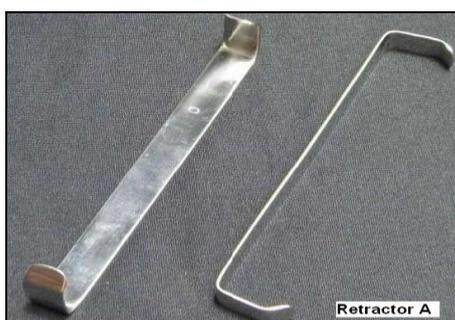
Figure 1 – Retractor A.

Four surgical instruments, two Farabeuf Retractors and two skin scissors, were selected for this study and are shown below in Figures 1 - 4. The Farabeuf Retractors are surgical mechanical elements intended to facilitate exposure of the operative field. They are used to ward off the edges of lesions, skin, subcutaneous tissue and superficial muscles. Skin scissors are used to cut and remove sections of skin.

The data sheet accompanying the retractor claims that it is made of AISI-304, an austenitic stainless steel containing between 18% and 20% chromium, 2% manganese, and between 8% and 10.50% nickel [12]. Analysis of the stainless steel in question showed that it is a ferritic stainless steel containing 10.50% chromium and 0.4% manganese. Ferritic steels are generally used in the manufacture of household appliances, coins and cutlery. Figure 5, below, presents the microstructure of retractor A.

- Analysis of Retractor A showed that it was made of a different steel than the one claimed by the manufacturing company, a steel that is not recommended for the purpose of Retractor A. Of the instruments analyzed, Retractor A was among those for sale at the lowest price;

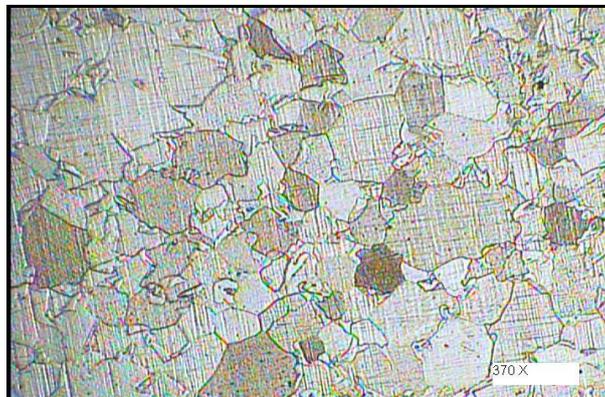
Figure 5 – Microstructure of Retractor A (370 x magnification).

Metallographic laboratory analysis and scanning electron microscopy (SEM) associated with the Energy Dispersive X-ray Fluorescence (EDX) performed on retractor A revealed the characteristics of a different steel than that which the manufacturer claims that these surgical instruments are made of household appliances, coins and cutlery.

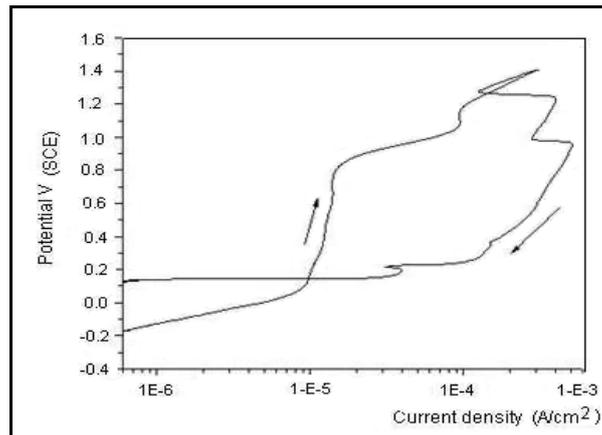
Figure 7, below, shows the polarization curve of Retractor A, obtained in the presence of enzymatic detergent solution.

Figure 7 – Cyclic polarization curve for retractor A in enzymatic detergent solution.

The anodic potentiodynamic polarization cyclic corrosion test allows the measurement of changes in current density as a function of potential. It starts by calculating the corrosion potential and progresses through other variables before returning to corrosion potential. Thus several parameters can be calculated from the results of this one test, including protective potential and pitting potential as well as corrosion potential. The protective potential can be defined as the potential below which pits that have already been formed are passivated. It is the point of intersection at which the reversal potential scan occurs. At the pitting potential, the current density increases sharply, but there is almost no change in the potential. There is also a susceptibility to pitting which is related to the area under the curve loop of polarization: the bigger the loop area under the curve, the more susceptible the material is to the formation of pitting [11].

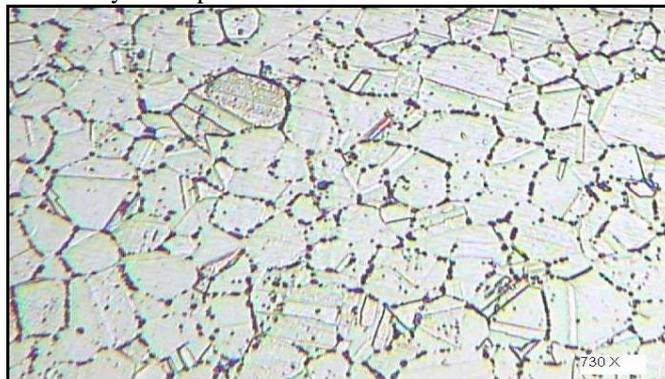
Metallographic analysis of Retractor B revealed that it is austenitic steel with a sensitized structure (Figure 8). The black points are the sensitized areas. Chromium-rich grain boundary precipitates lead to a local depletion of chromium immediately adjacent to these precipitates, leaving these areas vulnerable to corrosive attack from certain electrolytes. Basically, these elements form carbides in preference to Cr (Cr_{23}C_6) in the austenitic alloys. However, in some corrosive media such as acetic acid at room temperature and drinking water, alkaline solutions do not cause intergranular corrosion [13, 14].

Figure 8 – Microstructure of Retractor B (730 x magnification).

The data sheet accompanying retractor B claims that it is made of AISI 304 stainless steel, yet our analysis of the retractor indicated a chemical composition of 12.76% chromium, 0.67% manganese and 0.70% silicon. These two claims are totally incompatible.

- All samples tested showed some kind of problem with the quality of the material used in its manufacture;
- Retractor B was composed of sensitized stainless steel, which is susceptible to intergranular corrosion, and thus has a limited lifespan;

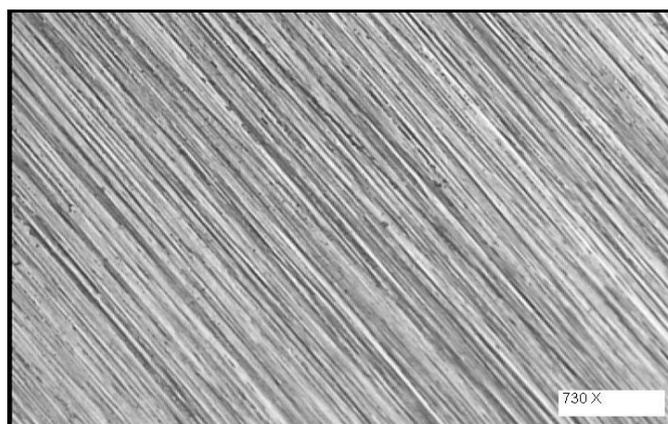
Polarization assays conducted with a sample of Retractor B did not reveal any evidence of pitting, as shown in Figure 9.

Figure 9 – Retractor B surface after polarization assay in enzymatic detergent solution (730 x magnification).

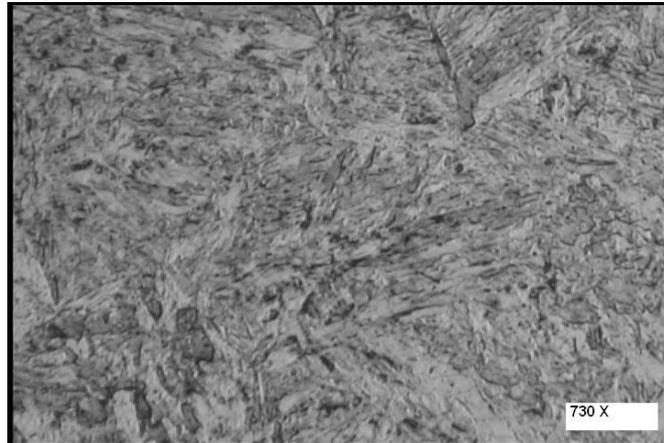
Metallographic analysis of Scissors C revealed a microstructure of martensitic stainless steel, shown below in Figure 10. Due to its high hardness, martensitic stainless steel is the most widely used in the manufacture of surgical instruments, such as scissors and scalpels [12]. The composition obtained by ADX-MEV was 11.83% chromium, 0.90% silicon and 0.20% aluminum. The data sheet accompanying the scissors claims that it is made of AISI-430, which contains between 16% and 18% chromium, 1% manganese and 0.75% nickel [15].

Figure 10- Scissors C microstructure (730 x magnification).

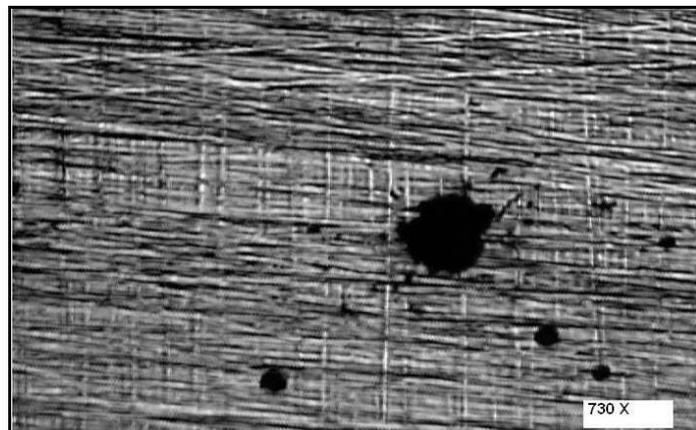
Polarization assays with Scissors C did not result in regulation, as shown in Figure 11 and in the polarization curve presented in Figure 12, below.

Figure 11 – Pitting visible in the surface of Scissors C after testing for polarization in enzymatic detergent solution (730 x magnification).

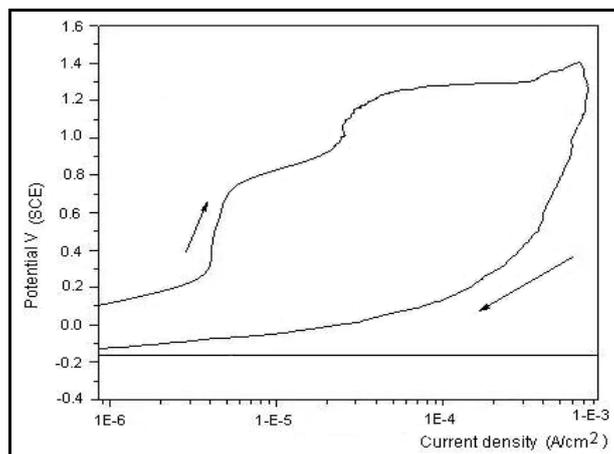
Figure 12 – Polarization curve of Scissors C in enzymatic detergent solution.

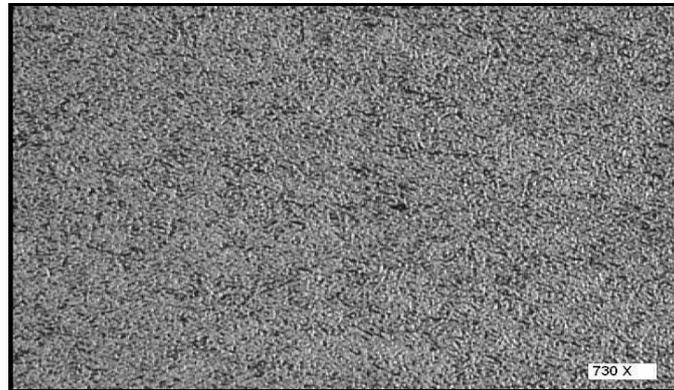
Scissors D has a metallographic microstructure difficult to identify, as shown in Figure 13. The manufacturer of this scissors did not specify the type of stainless steel used in manufacturing in the technical bulletin. The results of the ADX-MEV showed a composition of 12.76% chromium, 0.70% manganese and 0.67% nickel.

Figure 13 – Microstructure of Scissor D (730 x magnification).

- The company responsible for manufacturing Scissors D did not report the stainless steel used in manufacturing. The microstructure revealed was difficult to identify, and identification was only possible by means of scanning electron microscopy;

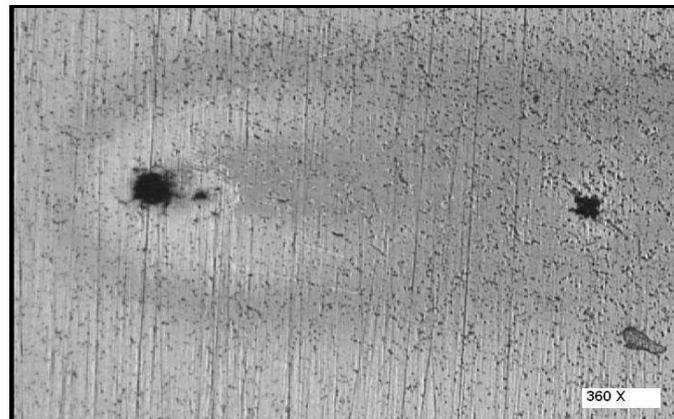
Figure 14, below, shows the pitting formed in the surface after the polarization test in samples of Scissors D in enzymatic detergent solution.

Figure 14 – Pitting visible in the surface of Scissor D after testing for polarization in enzymatic detergent solution (360 x magnification).

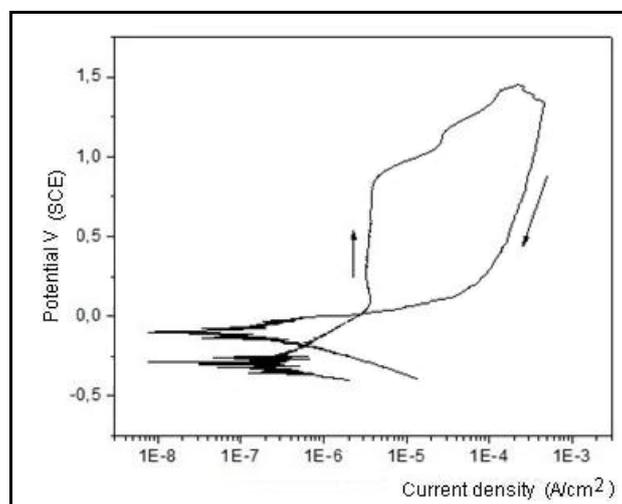
Figure 15, below, shows the polarization curve of Scissor D obtained in the presence of enzymatic detergent solution

Figure 15 – Polarization curve for Scissor D in enzymatic detergent solution.
