Structural Audit Of 30 Years Old Building

Aniket Raut, Prof. N.H Pitale , Dr. Dilip P. Mase

PG Student, Civil Engineering Department G. H. Rasoni College of Engineering Nagpur, India
Assistant Professor, Civil Engineering Department G. H. Rasoni College of Engineering Nagpur, India
Chartered Engineer Nagpur, India

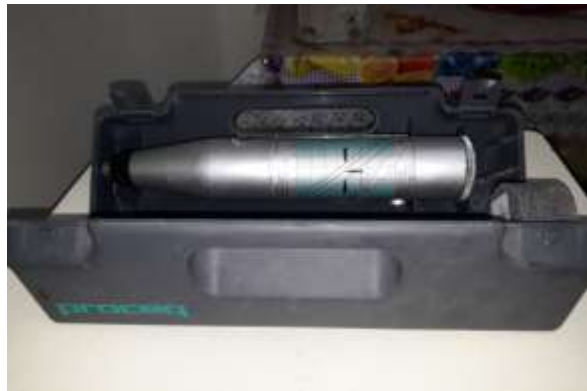
Fig. 1. Rebound Hammer Test

In 1948, Ernst Schmidt a Swiss Engineer developed a device for testing concrete, based upon rebound principle when a hammer strikes concrete. There is a metallic rod in Rebound hammer to which spring is attached. When The body of the instrument is pushed toward the concrete surface, the spring controlled mass rebounds and the extent of such rebound is an indication of hardness of concrete and therefore the rebound is taken to be related to the compressive strength of the concrete. For taking a measurement, keep the instrument perpendicular to the test surface. The test thus can be conducted horizontally on vertical surfaces and vertically upwards or downwards on horizontal surfaces. IS 13311 part II 1992 gives a standard test method for Rebound Hammer Test.

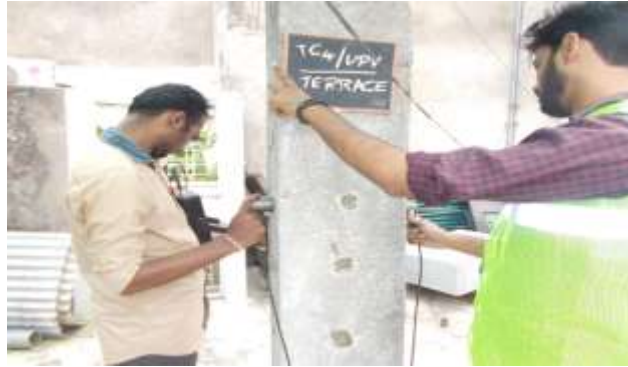
Fig II Ultrasonic Pulse Velocity Test

The strength of concrete in ultrasonic pulse velocity test is assessed by measuring the velocity of an ultrasonic pulse passing through it. The ultrasonic testing method is based on the use of equipment composed of transducers which produce and receive the ultrasonic wave. The time taken by pulse to travel from the transmitting to receiving transducers is measured by a timing circuit. A better quality of concrete is indicated by higher velocity while if the surface is not uniform and consist of cracks it is indicated by lower velocity. The pulse velocity in concrete will be represented in Km/sec or M/s. IS 13311 (Part I) 1992 gives a standard test method for Ultrasonic Pulse Velocity Test.

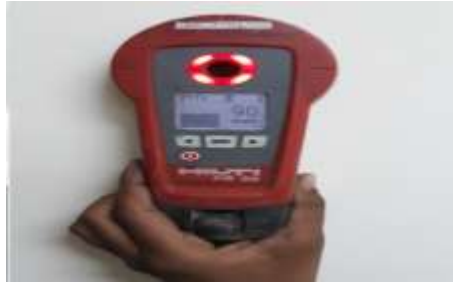
Fig. 3. Cover Meter

A cover meter is a device designed specifically for determining the “cover” to reinforcement bars in concrete, location of embedded rebars and estimation of size of embedded rebars. Cover is defined as being the distance from a given surface of a concrete element to the nearest part of a reinforcement bar or other embedded item. Knowing the diameter of the bar and their location is essential to understand the bar spacing and their placement, in existing structures where there are no structural drawings available. The cover thickness is important to estimate the extent of corrosion. Cover meter is important to ensure longer life for the structure.

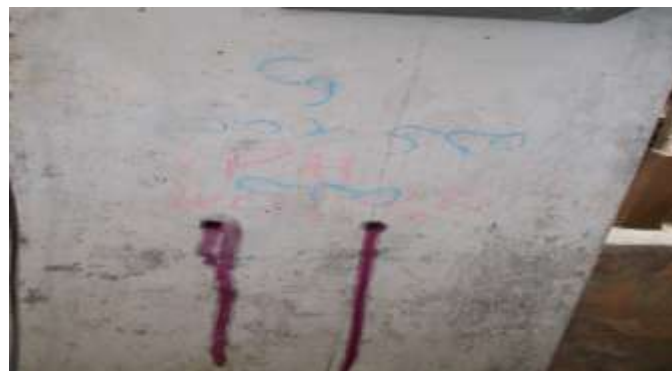
Fig. 4. Depth Of Carbonation Test

when the carbon dioxide in atmosphere in the presence of moisture reacts with hydrated cement, carbonation of concrete occurs. Carbonation process is also called as depassivation. Carbonation of concrete is associated with the corrosion of steel reinforcement and with shrinkage. The method to establish the extent of carbonation in concrete by applying a solution of 15mg Phenolphthalein & 10ml Ethanol diluted in 50ml of distilled water to a fresh fracture surface of concrete. The change of Pink color of concrete indicate carbonation free concrete while the uncolored indicated carbonation. The pH of concrete lowers when the carbon dioxide in the air comes in contact with concrete, the process is called carbonation. A standard pH meter is used to measure the pH of concrete. If pH value between 7 to 9 Concrete starts to break down and pH of the concrete below 8.6, suggesting carbonation.
