## Evaluation of the efficiency of (gypsum-lime) concrete used in the roofs of Mohamed Ali family buildings (1880 – 1900) and its impact on the preservation state of ceiling decorations

The ceiling is the subject of study

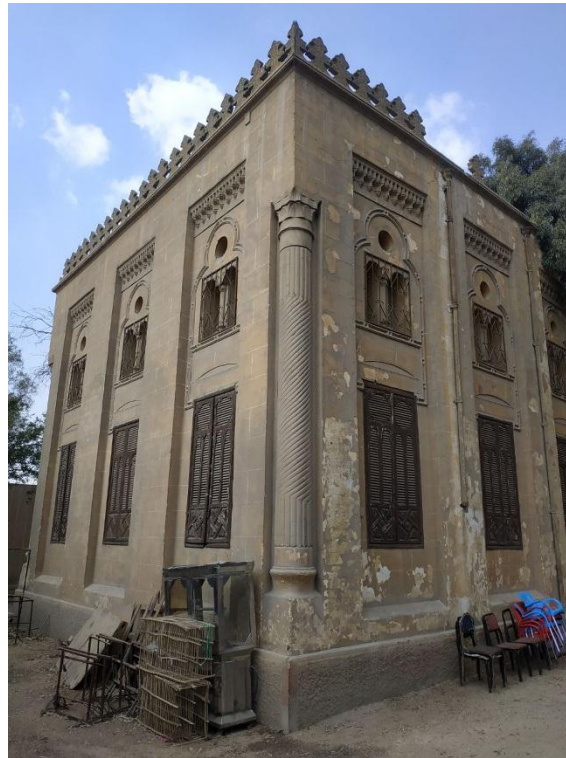
The building is a large burial chamber containing 6 graves. Each grave has a gilded marble composition. The area of the building is 85.5 m<sup>2</sup>, and its dimensions are 9 x 9.5 m. The height of the building is 10 m. The main entrance is located on the north side with a door measuring 3 m high and 160 cm wide. Its fillings are made in the shape of a plate. Al-Najmi (Islamic decorative design) . Around the door is a window on the right side. It is 2.5 meters high and 1 meter wide. Its fillings are made in the shape of Al-Maqali (Islamic decorative design). There is a similar window on the left side, and on each of the other facades of the building there are three windows. Similar wooden windows in the main façade , at the top of each, there are twin windows made of stucco windows covered with glass, surmounted by a A circle-shaped stucco windows covered with glass with a muqarnas (Islamic decorative design ) cornice at the top. Image (1)

Image (1) Shows the vault building from the outside

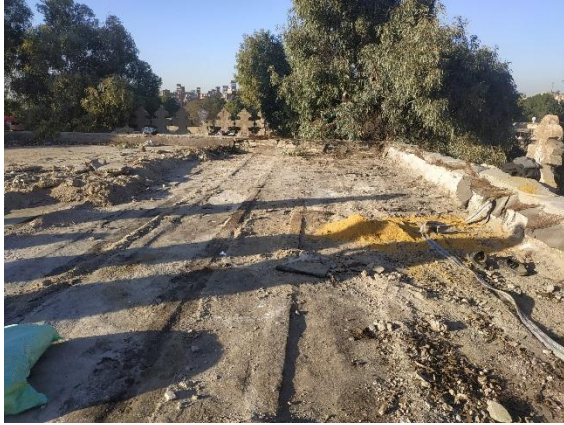
The method of implementing roofs in some buildings of the Muhammad Ali family was an imitation of the method of roofing with wooden beams by using iron beams instead of wooden beams, and they were distributed over the entire surface of the roof with spaces between them from 50 to 60 cm. In case that the length of the space exceeded 5 m, tensioners were made. In the middle of the iron beams to connect them together from the middle so that there was no deflection of the beams, and the space between each beam and the other was filled with cement concrete or white concrete so that this concrete entered the C-shaped cavity in the iron beams. [3] The ceiling here is filled with white concrete. Image (2 ,3)

Image (2) show Iron beams on top of the building

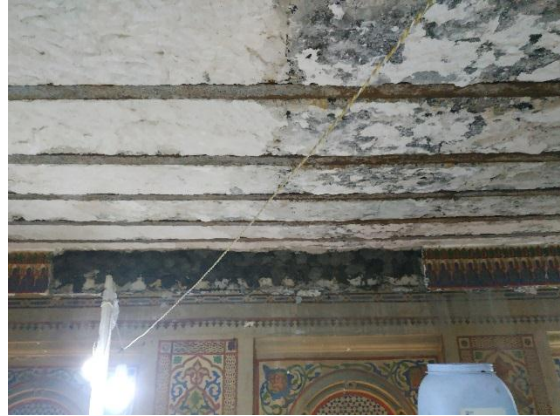
Image (3) show Iron beams from inside the building

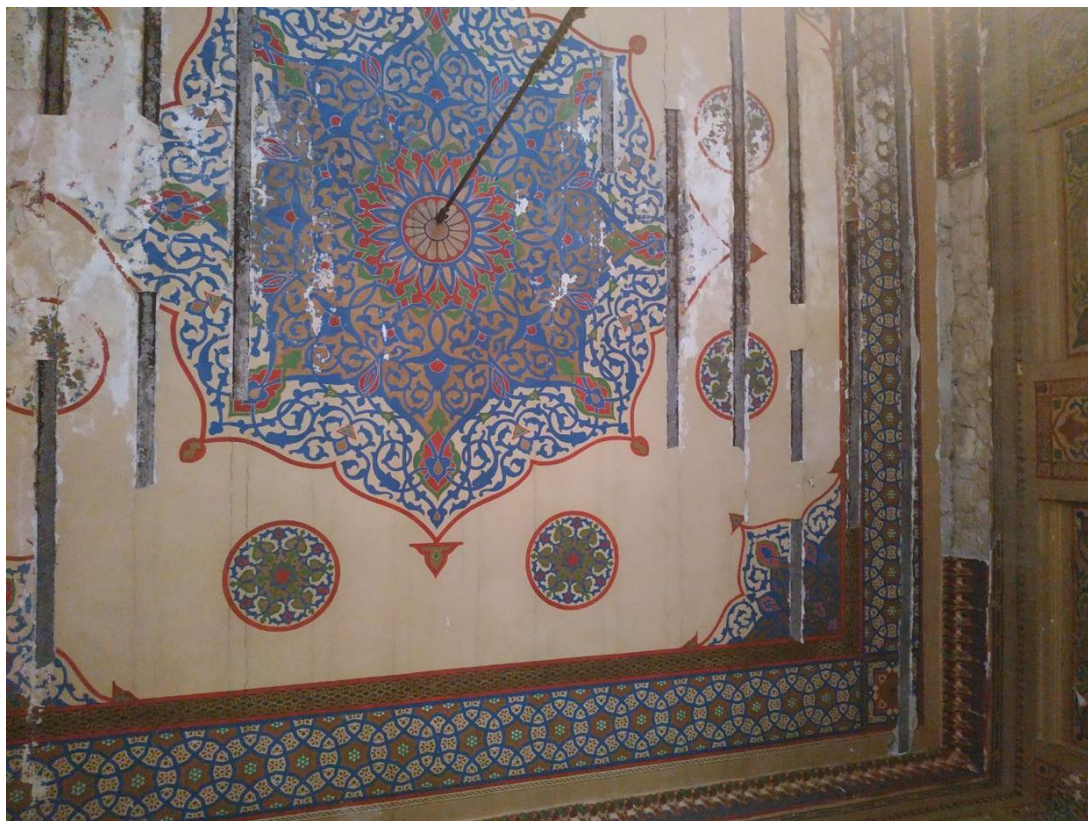
Over many years, the roof exposed to rainwater, which was not drained from the top of the roof, but was absorbed by the roof slab due to the insulation layer damage on top of the roof. The presence of water has some negative effects, such as The cracks spread parallel to the path of the steel beams, rusting of iron beams, separation of render layers, peeling of colors, and falling parts of concrete that fills between the iron beams. Image (4,5,6,7,8,9) Figure (1,2)

Image (4) shows the ceiling slab damages in the decoration area

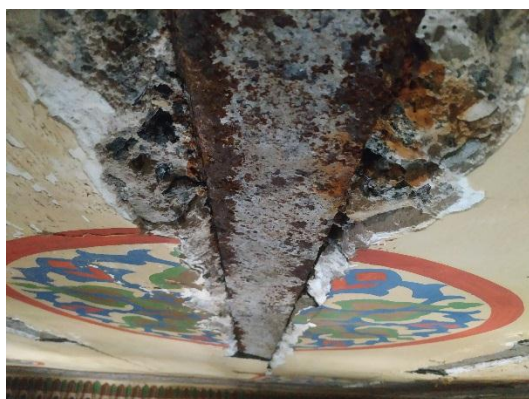
Image (5) shows The spread of rust in iron beams and roof concrete

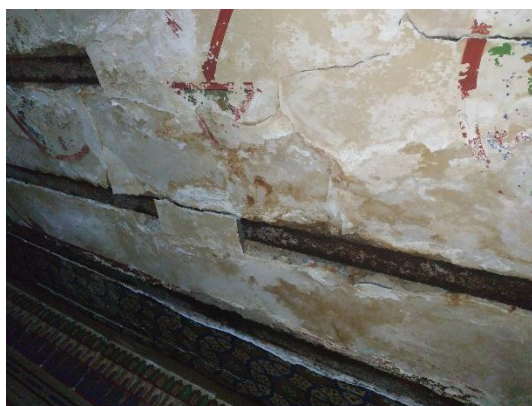
Image (6) shows peeling of colors, separation of render layers, and the spread of cracks

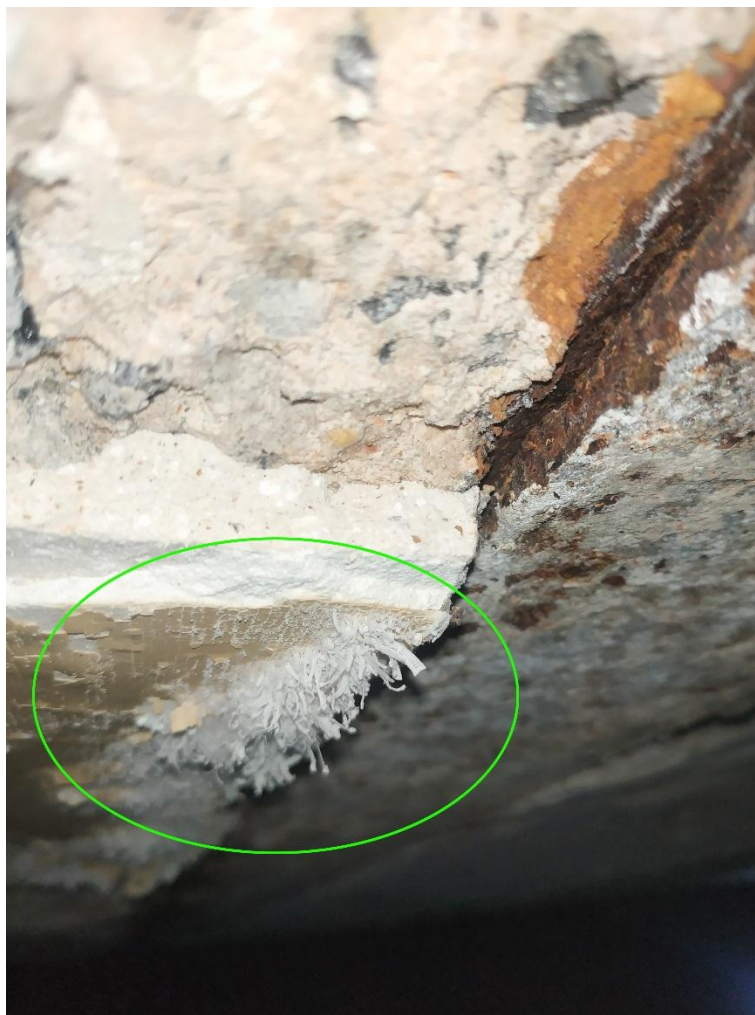
Image (7) shows render layers damage and the salts efflorescence on the color layer  
Surrounded by the green circle, the salt sample was taken from these salts efflorescence

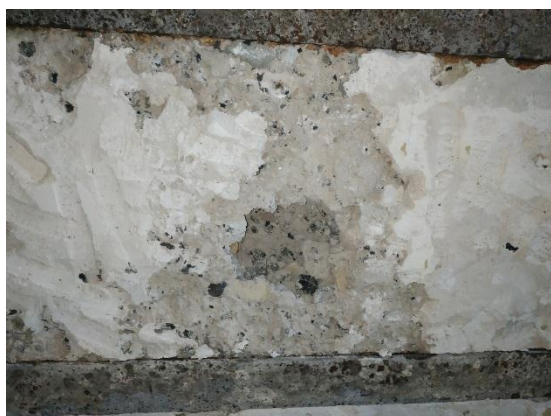
Image (8) shows Parts of concrete falling

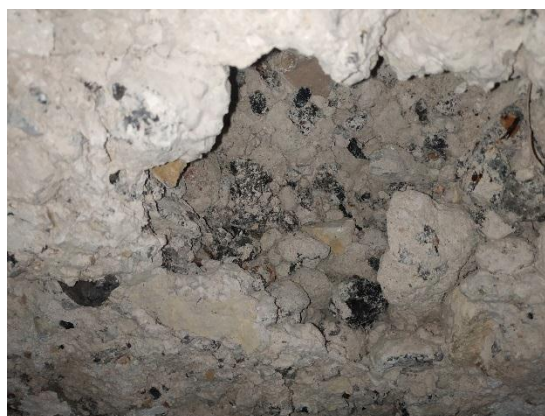
Image (9) shows Details of the location of the loss of concrete (the concrete sample that was studied)

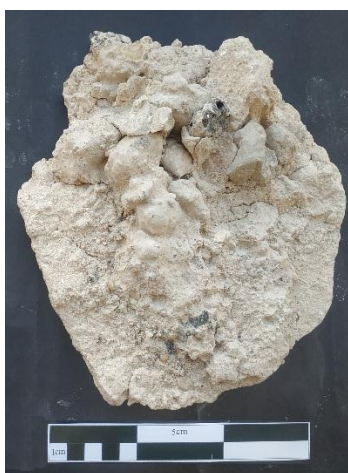
Image (10) of a sample of fallen concrete

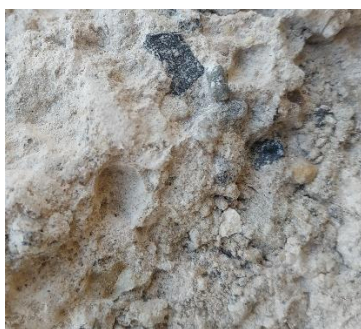
Image (11) detailing the components of concrete, showing a white binder, black fillers, and small aggregate of limestone and sand.

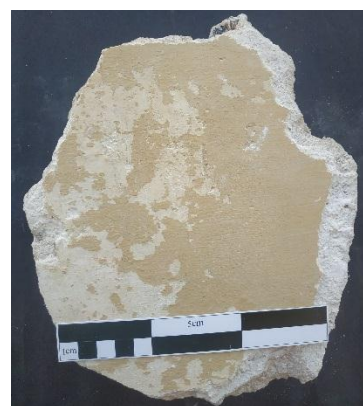
Image (12) of the layers of render and colors on the concrete sample

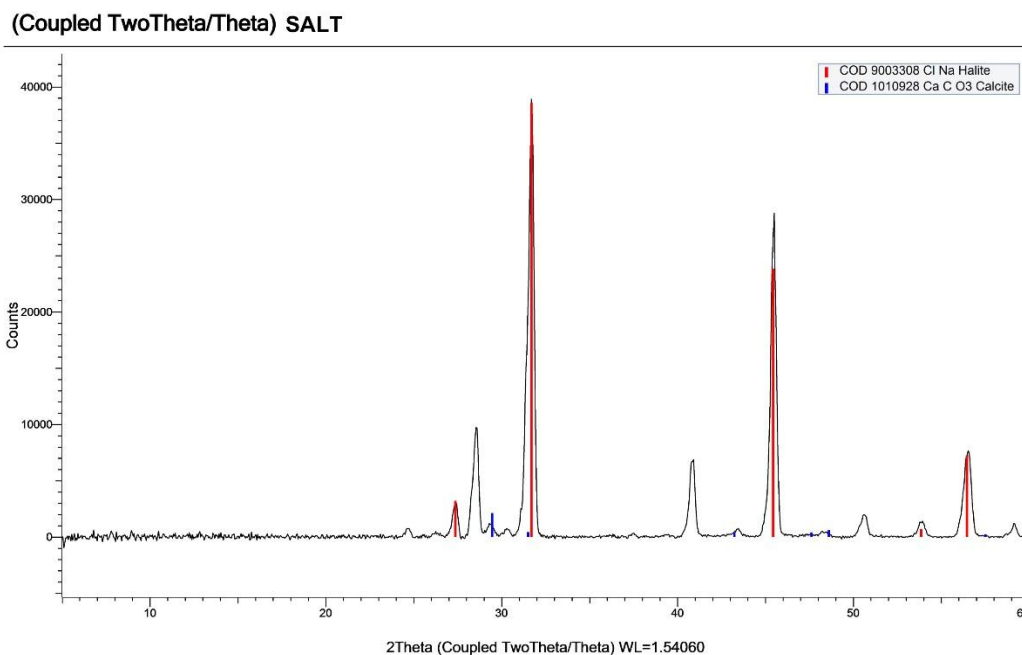
The presence of salt exceeding 92% and the salt efflorescence caused the damage to the render layer, the displacement of the components of the render happened with the salt efflorescence in the outer surface of render , the disintegration and damage of render layer in the lower part of ceiling happened due to the periodicity

of salt efflorescence Which occurs because the proximity of water sources . Calcite presence confirms that the render is calcareous. Figure (5 )

Figure (5 ) shows the X-ray diffraction pattern of the sample SALT

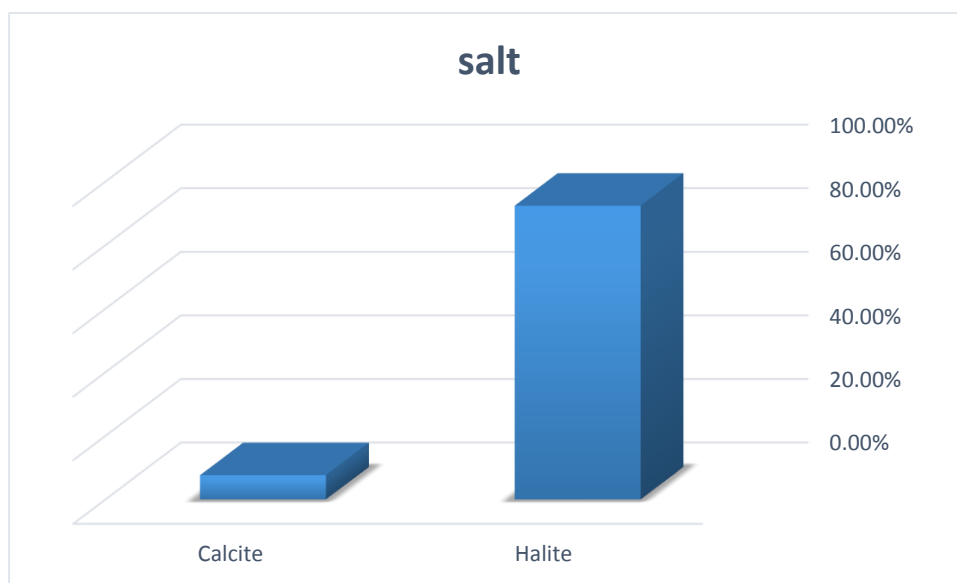
Figure (6 ) shows the percentages of minerals that consist the sample SALT

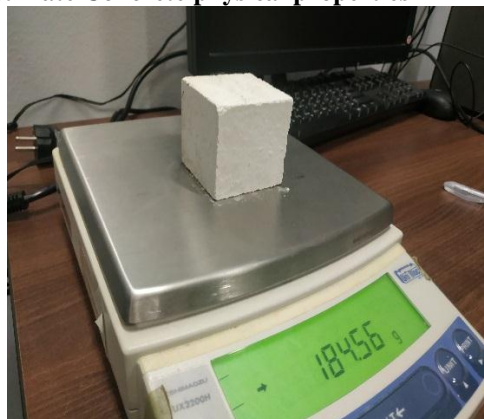
Image (29) shows Weighing samples to estimate their physical properties

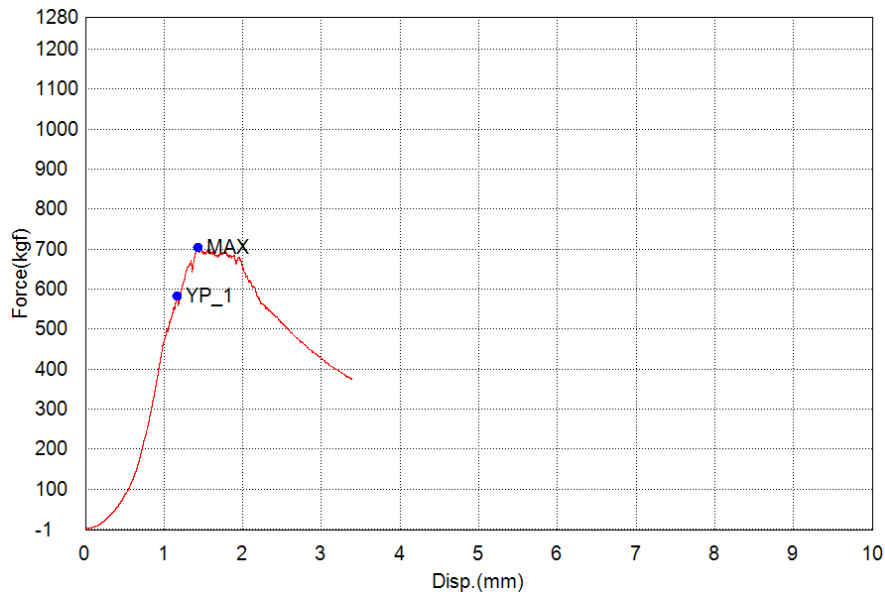
Figure (13) shows the compressive force until collapse of sample 1

It must be noted that the compressive strength test for samples had a resilience point, especially the sample that had been subjected to aging and had some amount of moisture, Sample 1, 2 Figure (13 ,14) Table (10 ,11)

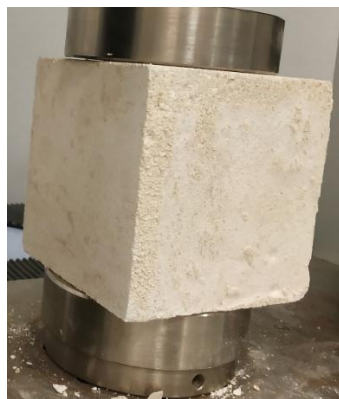
Image ( 36) shows the compression test of cubes Sample 3 (10 cm<sup>3</sup>)

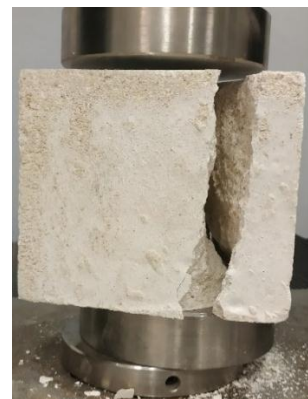
Image ( 37) showing the collapse of the cube Sample3

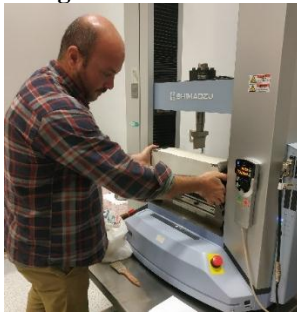
Image (38 ) shows the mock-up being placed on the test device

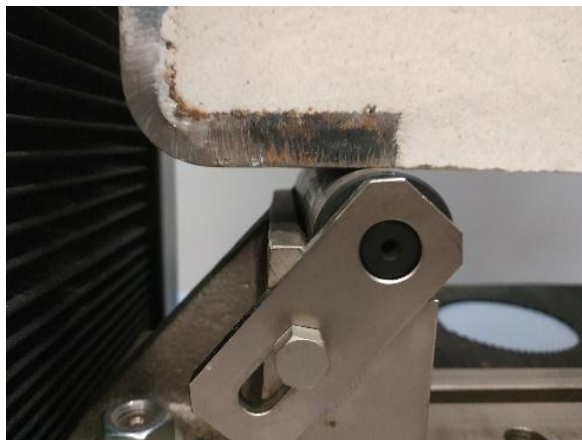
Image (39 ) shows supporting pins before testing

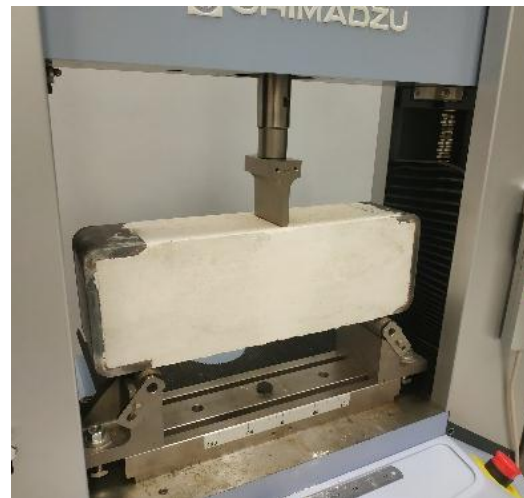
Image ( 40) shows loading pin before testing

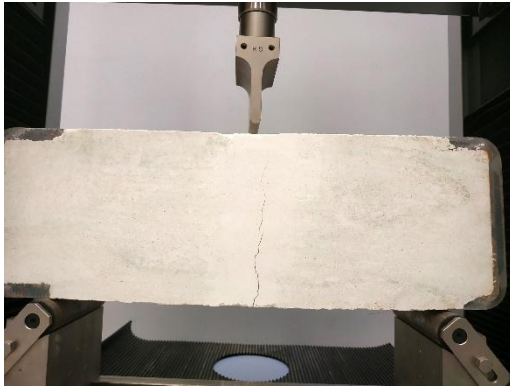
Image (41 ) showing the collapse of the mock-up

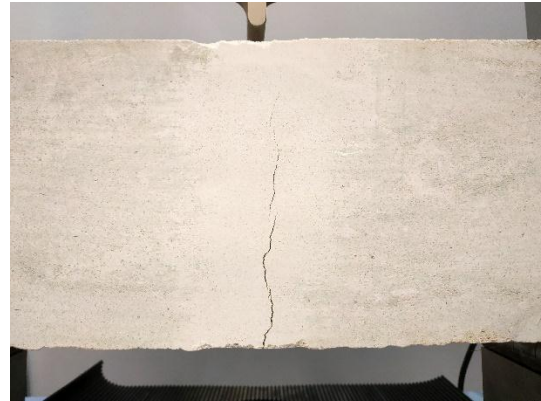
Image (24 ) showing the collapse of the mock-up
